# **Baseline Survey Report**

# on Construction and Demolition Waste Landfills

# in Hanoi, Vietnam

October 2019

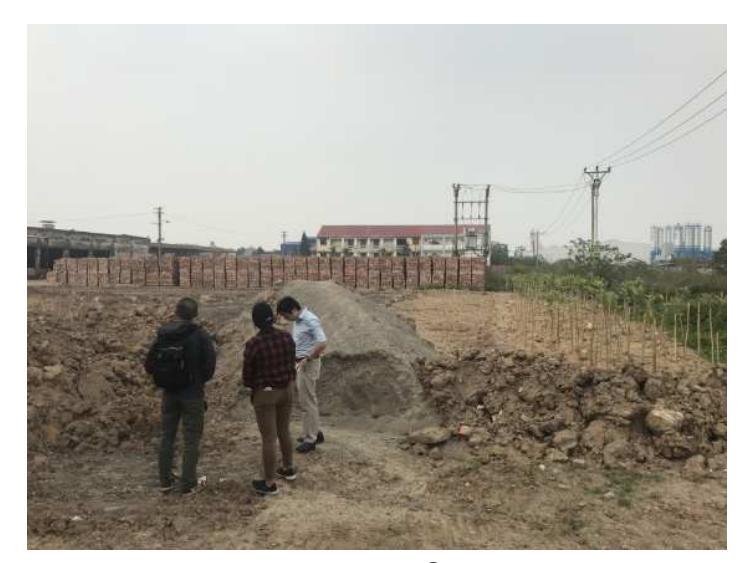
(a) Point ①

The most of piled CDW has been removed already.

There is a big excavated ground hole at the central zone of the site.

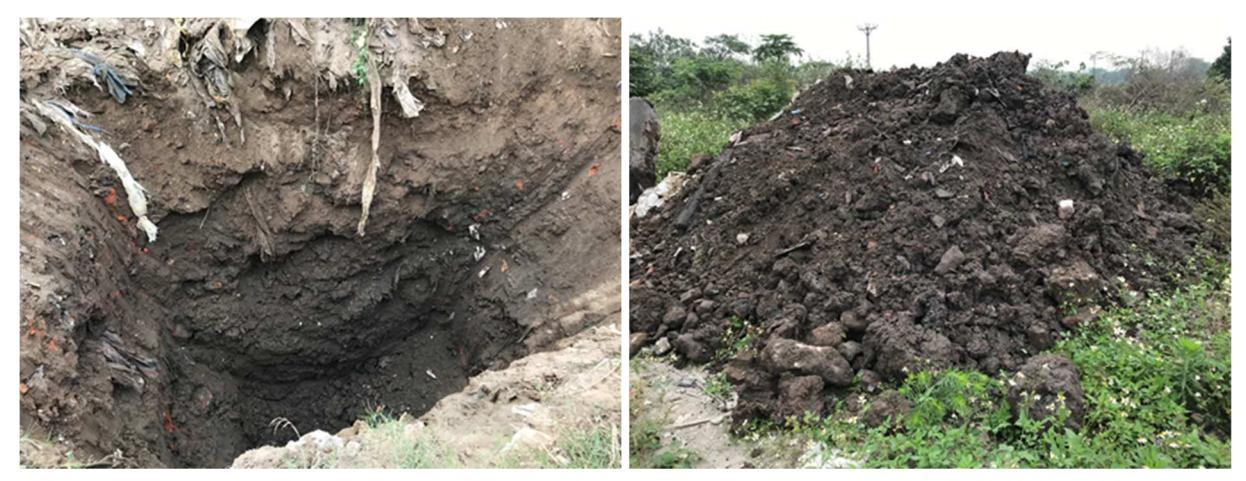
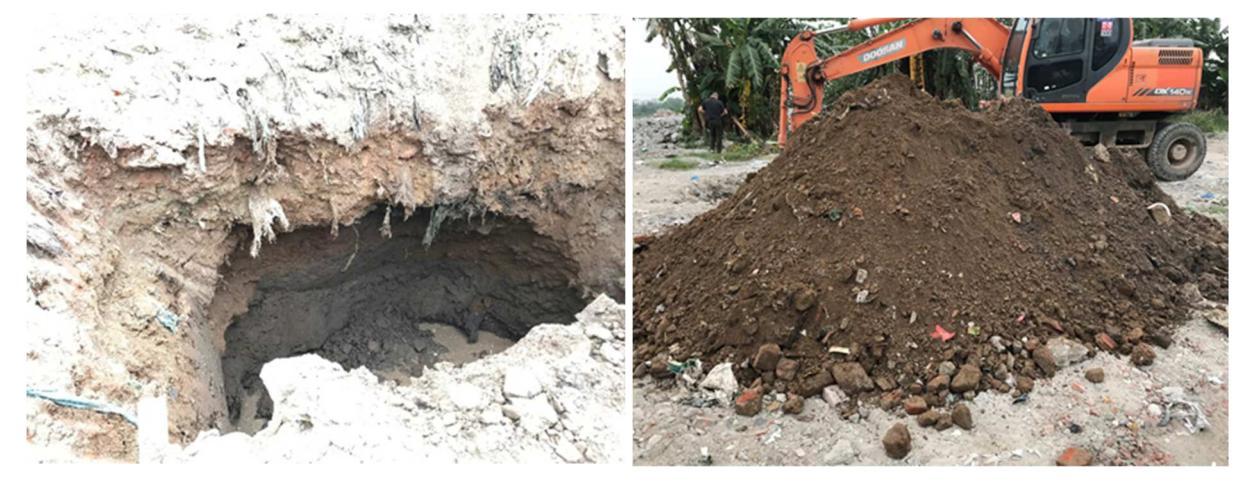
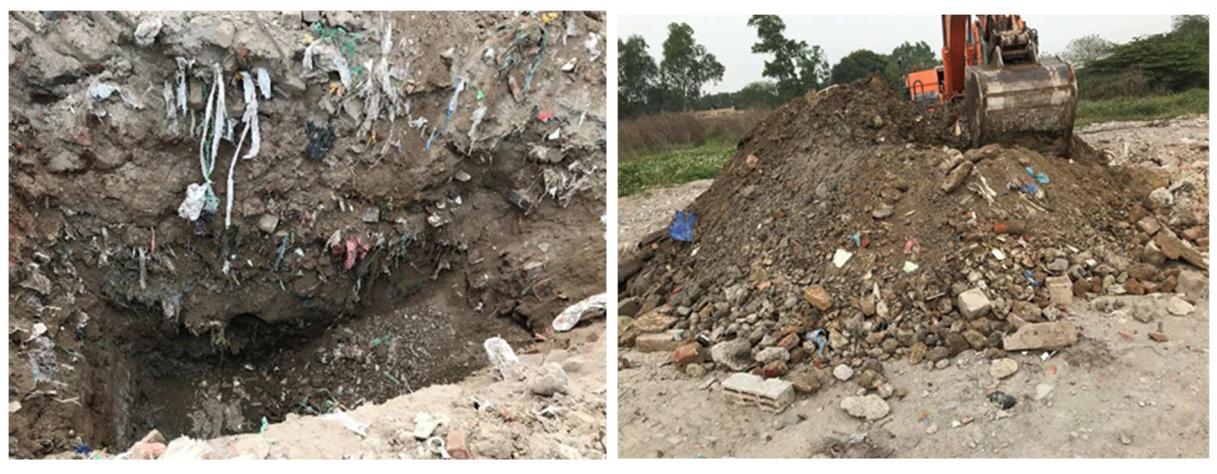
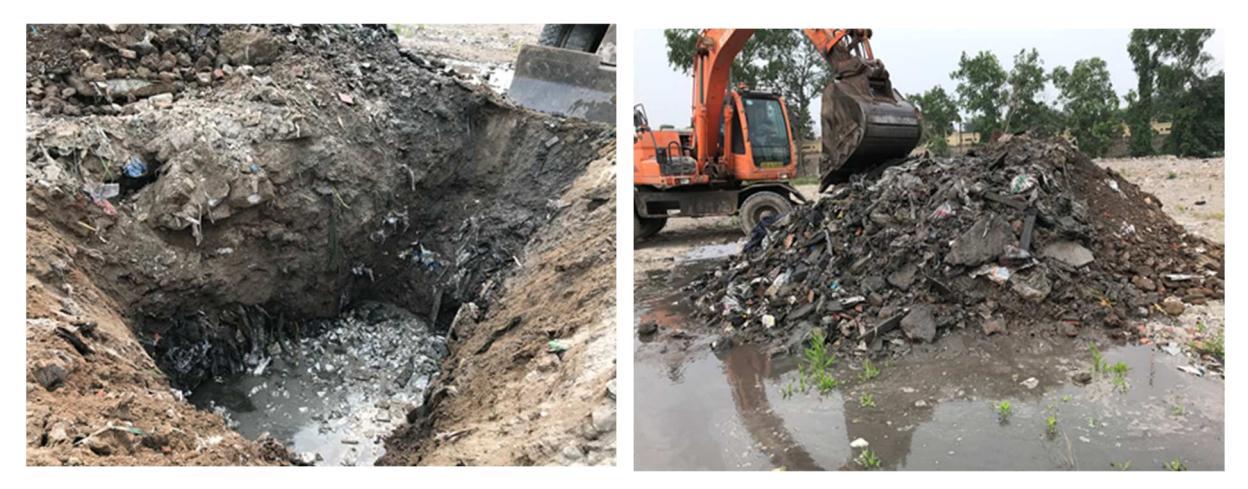
(d) Point ④
 Figure 10. Photos of Vinh Quynh CDW landfill.
 (Locations of Point ① to ④ are given in "4. Sketch of landfill site" of the check sheet)

Discolored water: □No ☑Yes (at Point ④	) color, pH (	), (	) ppm
Caving: $\square$ No $\square$ Yes ( a big hole with 10 ~ depth	1		)
Informant			
Source: ILand owner Deperation company	Local citizen		
Fire disaster in the past: □No □Unknown □Yes	(		)
Type of waste: (Soil, sludge, CDW, some dome	estic waste		)
Incinerator:  ¬No  Yes (			)
Other:			
Previously the land was used as a rice field.

*Locations of Point ① to ④ are given in "4. Sketch of landfill site" of the check sheet
Ground excavation down to ~ 3m depth at 4 different points inside (Point $(1), (2), (3)$ , and $(4)$ ).
Groundwater/perched water was observed at around 3 m depth at all points.
At points $①$ and $②$ , dumped concrete and clay bricks were observed within 1 m depth and a layer
with dumped soil and sludge was observed down to ~ 2m.
At points $(3)$ and $(4)$ , dumped concrete and clay bricks mixed with soil were observed down to ~3
m in depth.

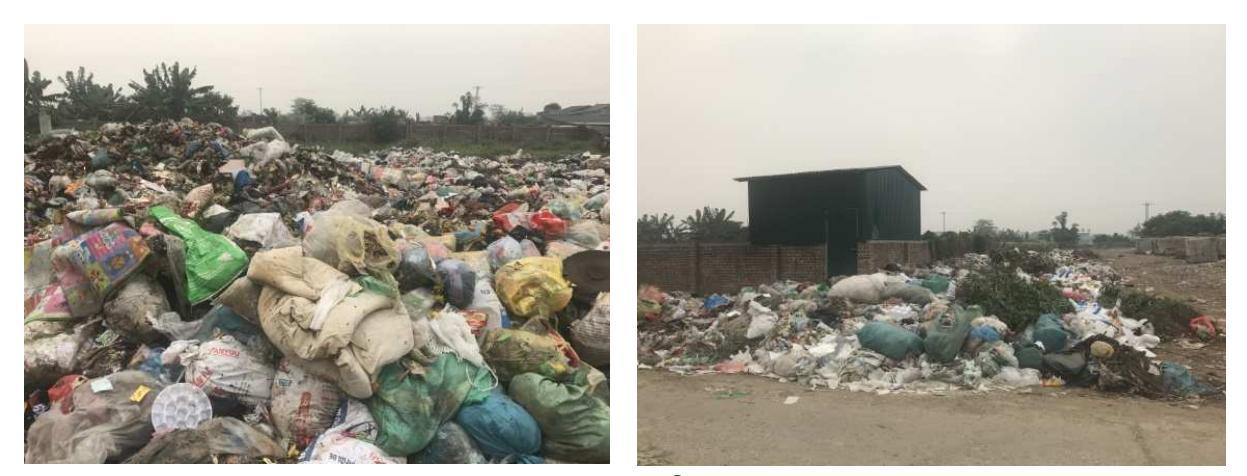
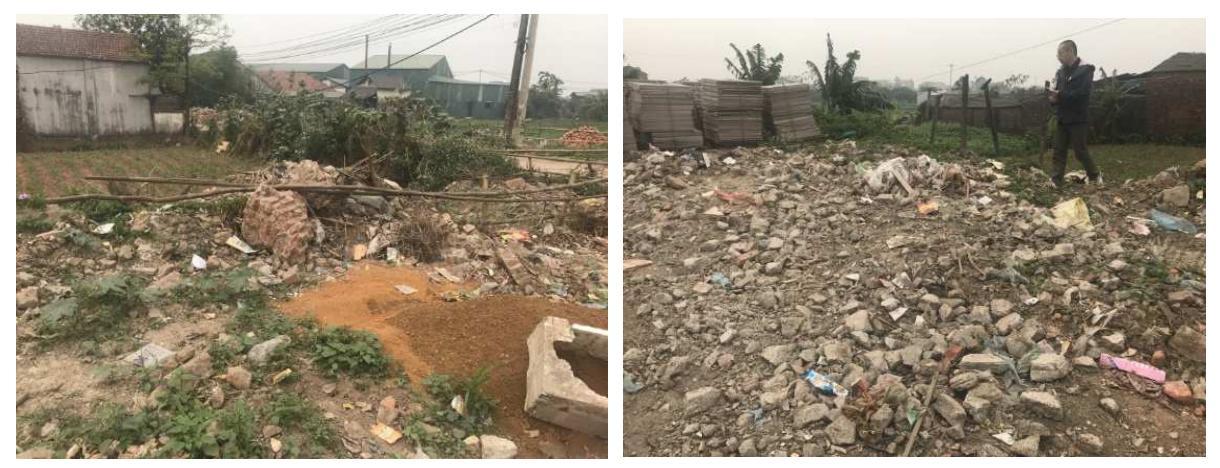
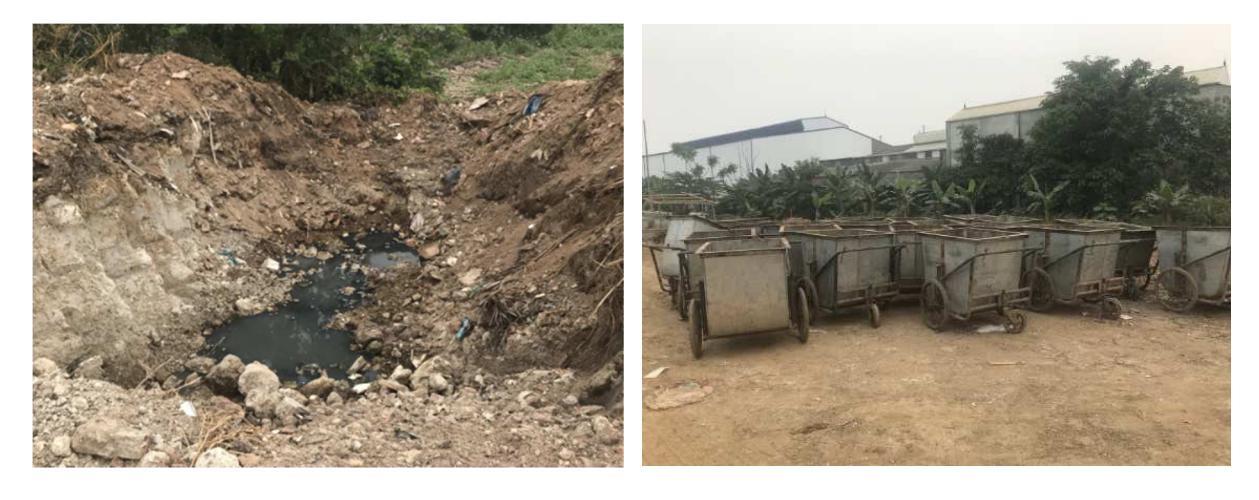
(c) Point ③ (d) Point ④ Figure 11. Photos of Duong Lieu CDW landfill. (Locations of Point ① to ④ are given in "4. Sketch of landfill site" of the check sheet)

Collapse of Wall:  $\Box$ No  $\Box$ Yes ( ~ 1m collapse of retaining clay wall

Collected domestic waste and CDW are dumped in the area surrounded by brick walls

There were a lot of scattering of domestic waste with rotten smell.

Small piles of CDW were distributed near the domestic waste station.

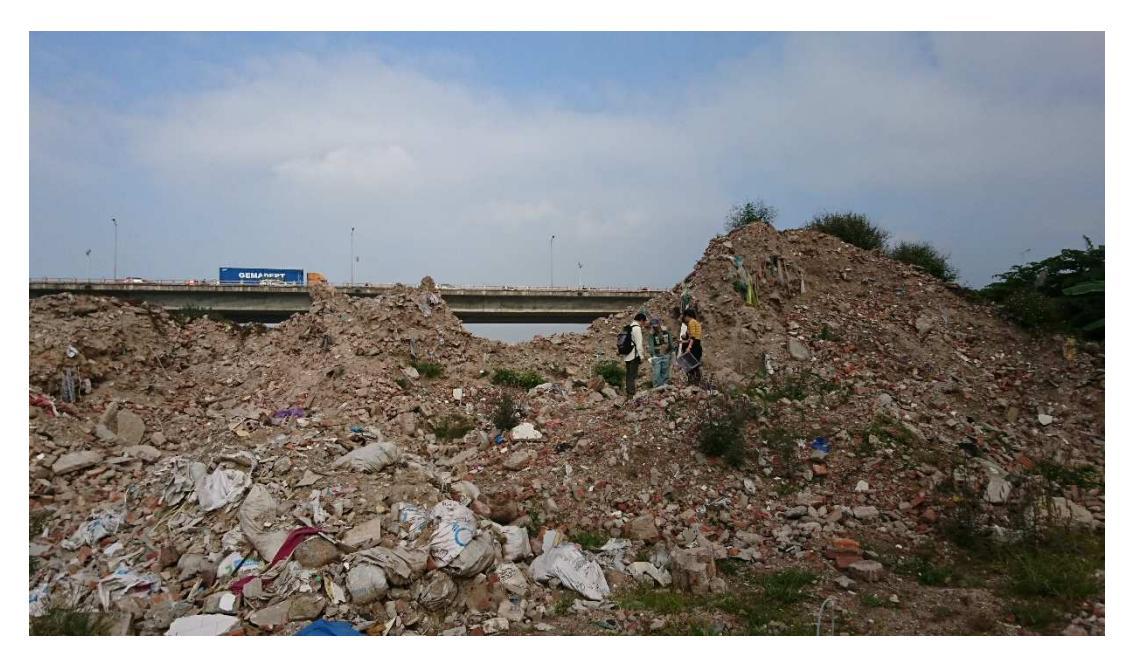
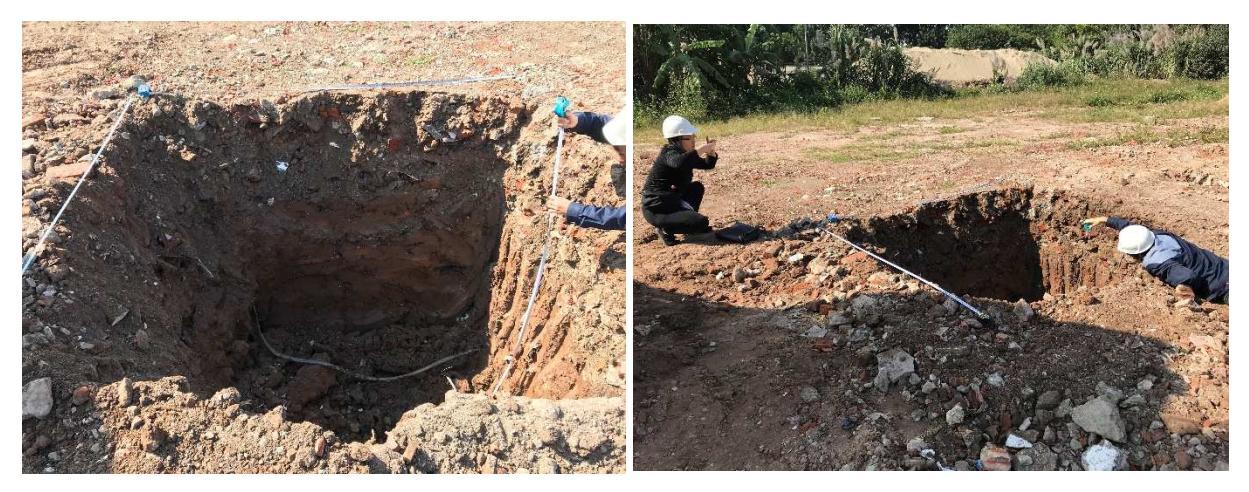
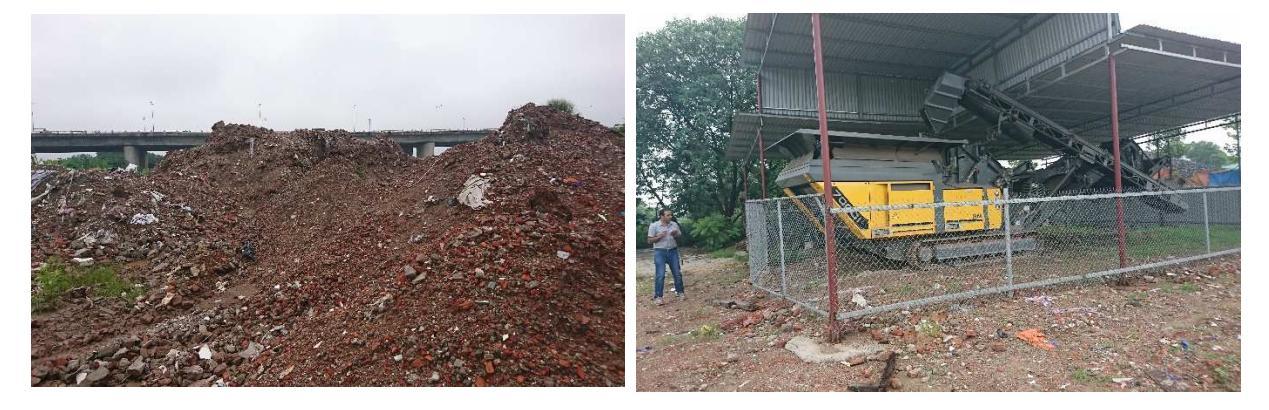
Figure 12. Photos of Thanh Tri CDW landfill. (Locations of Point ① to ④ are given in "4. Sketch of landfill site" of the check sheet)

Dumped CDW was piled on the ground (height ~ 3-4 m).

Stock yards of construction materials such as crushed stone and sand were located next to the disposal site.

A mobile type crushing machine is stored in the site.
