# **Baseline Survey Report**

# on Construction and Demolition Waste Landfills

# in Hanoi, Vietnam

October 2019

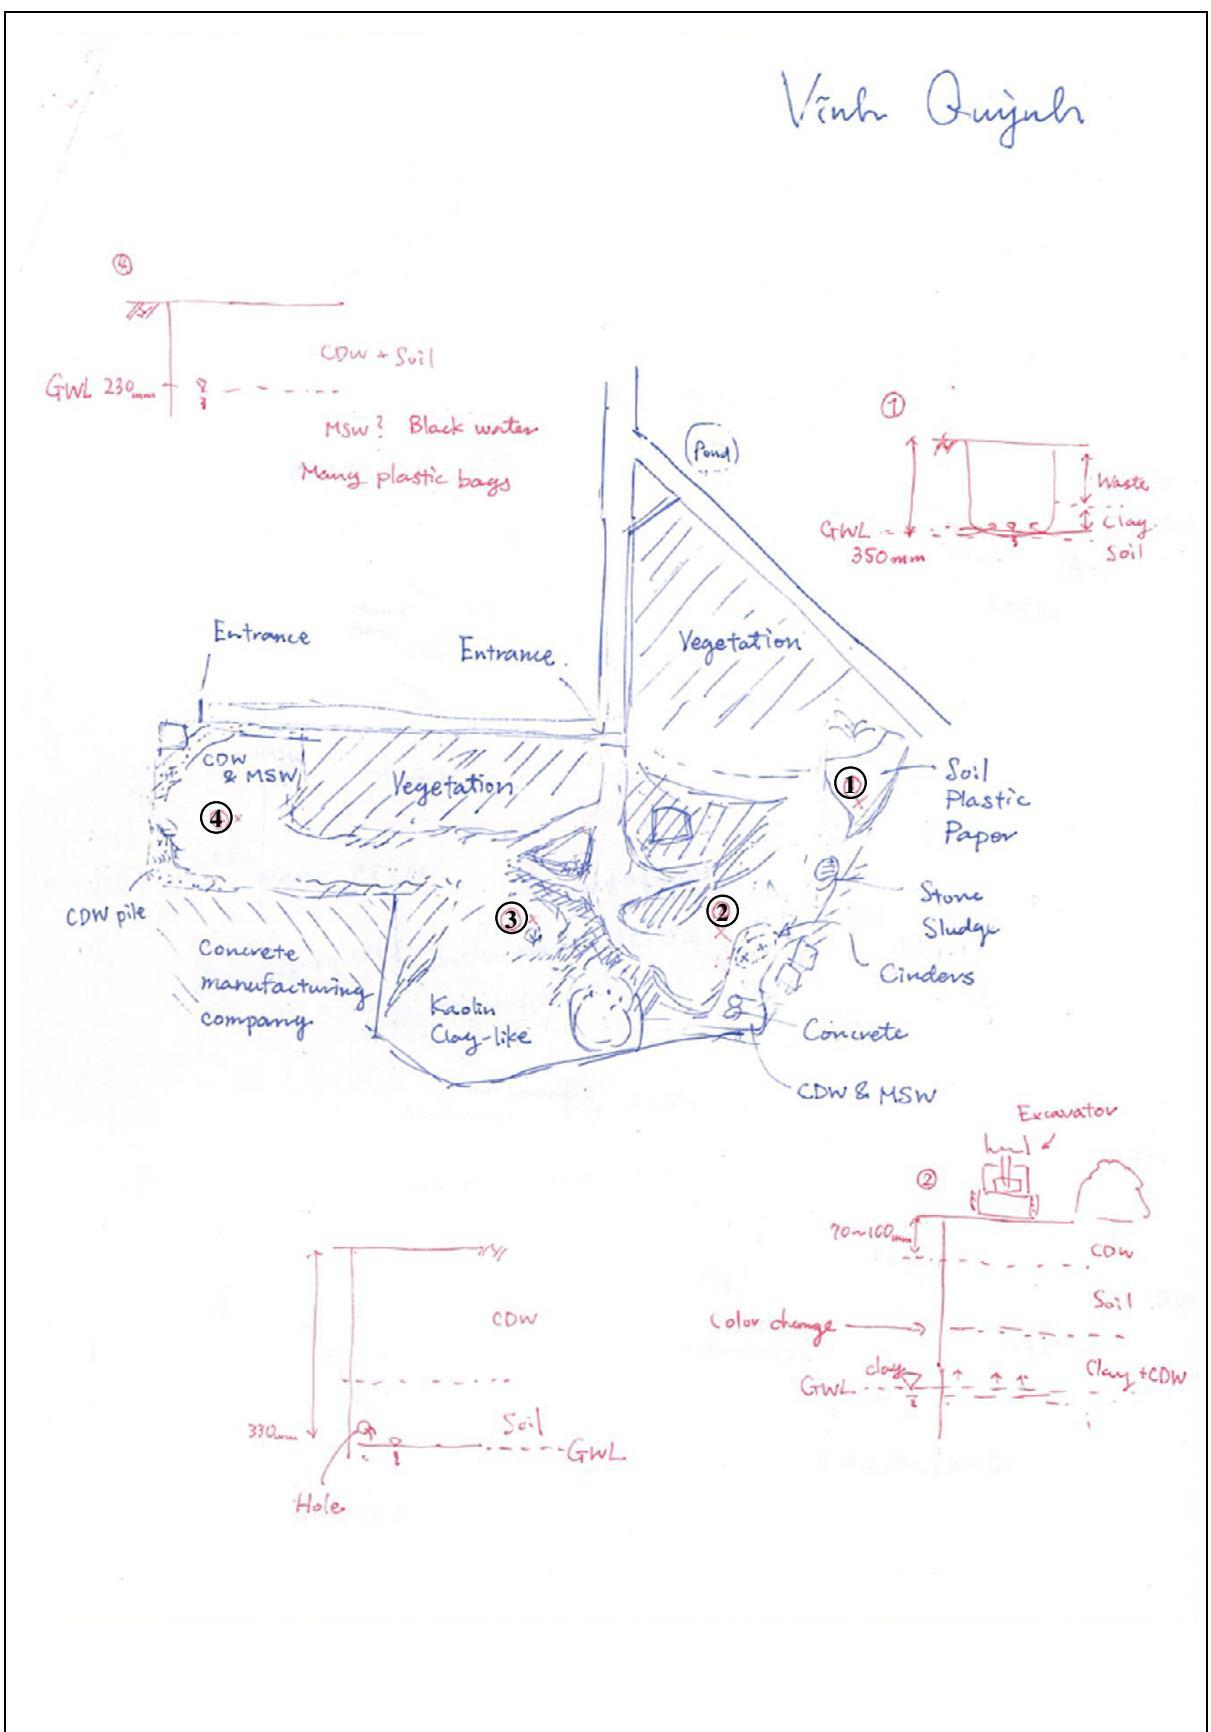
## 4. Sketch of landfill site

*Locations of Point ① to ④ are given in "4. Sketch of landfill site" of the check sheet
Ground excavation down to ~ 3m depth at 4 different points inside (Point $(1), (2), (3)$ , and $(4)$ ).
Groundwater/perched water was observed at around 3 m depth at all points.
At points $①$ and $②$ , dumped concrete and clay bricks were observed within 1 m depth and a layer
with dumped soil and sludge was observed down to ~ 2m.
At points $(3)$ and $(4)$ , dumped concrete and clay bricks mixed with soil were observed down to ~3
m in depth.
